ENGINEERING EVALUATION OF POST-LIQUEFACTION RESIDUAL STRENGTH

(VOLUME 2, PART 1: APPENDIX A)

Geotechnical Research Report No. UCB/GT/22-01
Department of Civil and Environmental Engineering
University of California at Berkeley

Back-Analyses of Class A and Class C Liquefaction Failure Case Histories

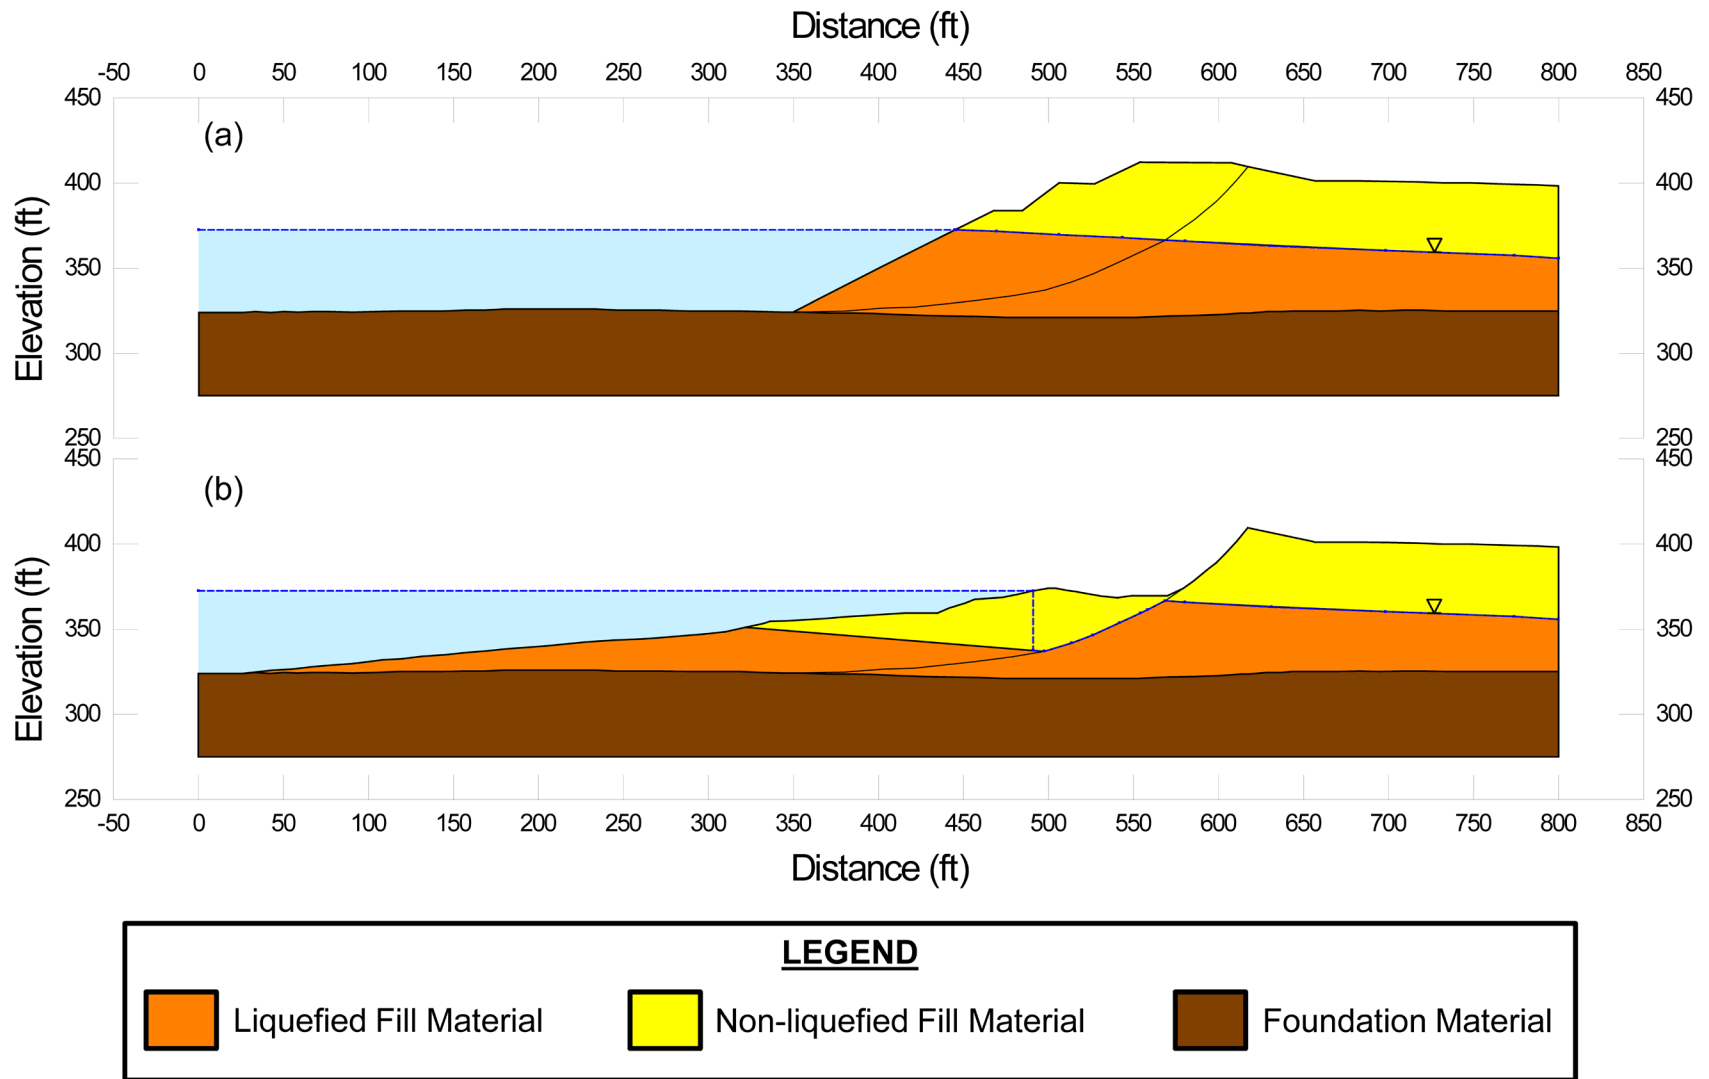
Figure A.1.3: Wachusett Dam at Station 23+20: (a) Pre-failure geometry and best-estimate failure surface for initial yield stress analyses, and (b) post-failure geometry and best-estimate failure surface for post-failure residual geometry analyses.

Figure A.1.3(a) also shows the best estimate failure surface. The failure surface is relatively well constrained at the back heel by the observable failure scarp. The precise location of the failure surface at the base of the failure is uncertain, but the most critical failure surfaces in terms of lowest Factor of Safety for a given value of strength within the liquefied shell fill materials are those that go right to the bottom of the fill. The potential depths are then constrained by the very dense foundation soils. Additional analyses were performed, varying this failure surface; the shape at the lower back heel was varied, and the failure surface was allowed to occur at various elevations slightly above the base of the shell fill. These variations were performed to evaluate sensitivity of the resulting calculated values of $S_{r,yield}$.

For the best estimate geometry, conditions, and failure surface described above and shown in Figure A.1.3, the resulting value of post-liquefaction yield strength was found to be $S_{r,yield} = 829$ lbs/ft². Sensitivity analyses were then performed, varying the details and location (at depth) of the failure surface, unit weights, and friction angles for the non-liquefied upper crest and non-liquefied upper core zones. These analyses suggested that there was little likelihood that this failure would have proceeded in an incrementally progressive manner, and so this failure was modeled only as a monolithic event, with the full eventual sliding mass beginning to move largely coherently at the inception of failure. The resulting range of values of $S_{r,yield}$ for combinations of modeling assumptions and details considered to be reasonable was found to be $S_{r,yield} \approx 752$ to 909 lbs/ft².

The calculation of the “apparent” post-liquefaction strength ($S_{r,resid/geom}$) required to produce a calculated Factor of Safety equal to 1.0 based on residual geometry is illustrated in Figure A.1.3(b). This figure shows the phreatic surface, and the failure surface, used to calculate the best-estimate value of $S_{r,resid/geom}$, based on the best estimate modeling parameters as described in the previous section. An additional detail here is the shear strength modeled at the base of the portion of the upstream toe of the embankment that traveled out into the reservoir. This was the first filling of the reservoir, so there were no loose reservoir sediments accumulated yet at the upstream toe. There may have been some hydroplaning, however, as the embankment materials moved rapidly into the reservoir. The incremental inertial analyses presented in Section A.1.5 that follows indicate that the maximum velocity was on the order of approximately 14.3 ft/sec, and the velocity during most of the run-in was lower. As discussed, it is not possible to fully accurately determine the degree of hydroplaning that would have occurred. The best estimate analysis of $S_{r,resid/geom}$ was performed assuming that shear strength at the base of the embankment materials that entered into the reservoir was 100% of $S_{r,resid/geom}$. The resulting best estimate calculated value of “apparent” post-liquefaction strength based on post-failure residual geometry was $S_{r,resid/geom} \approx 81 \text{ lbs/ft}^2$.

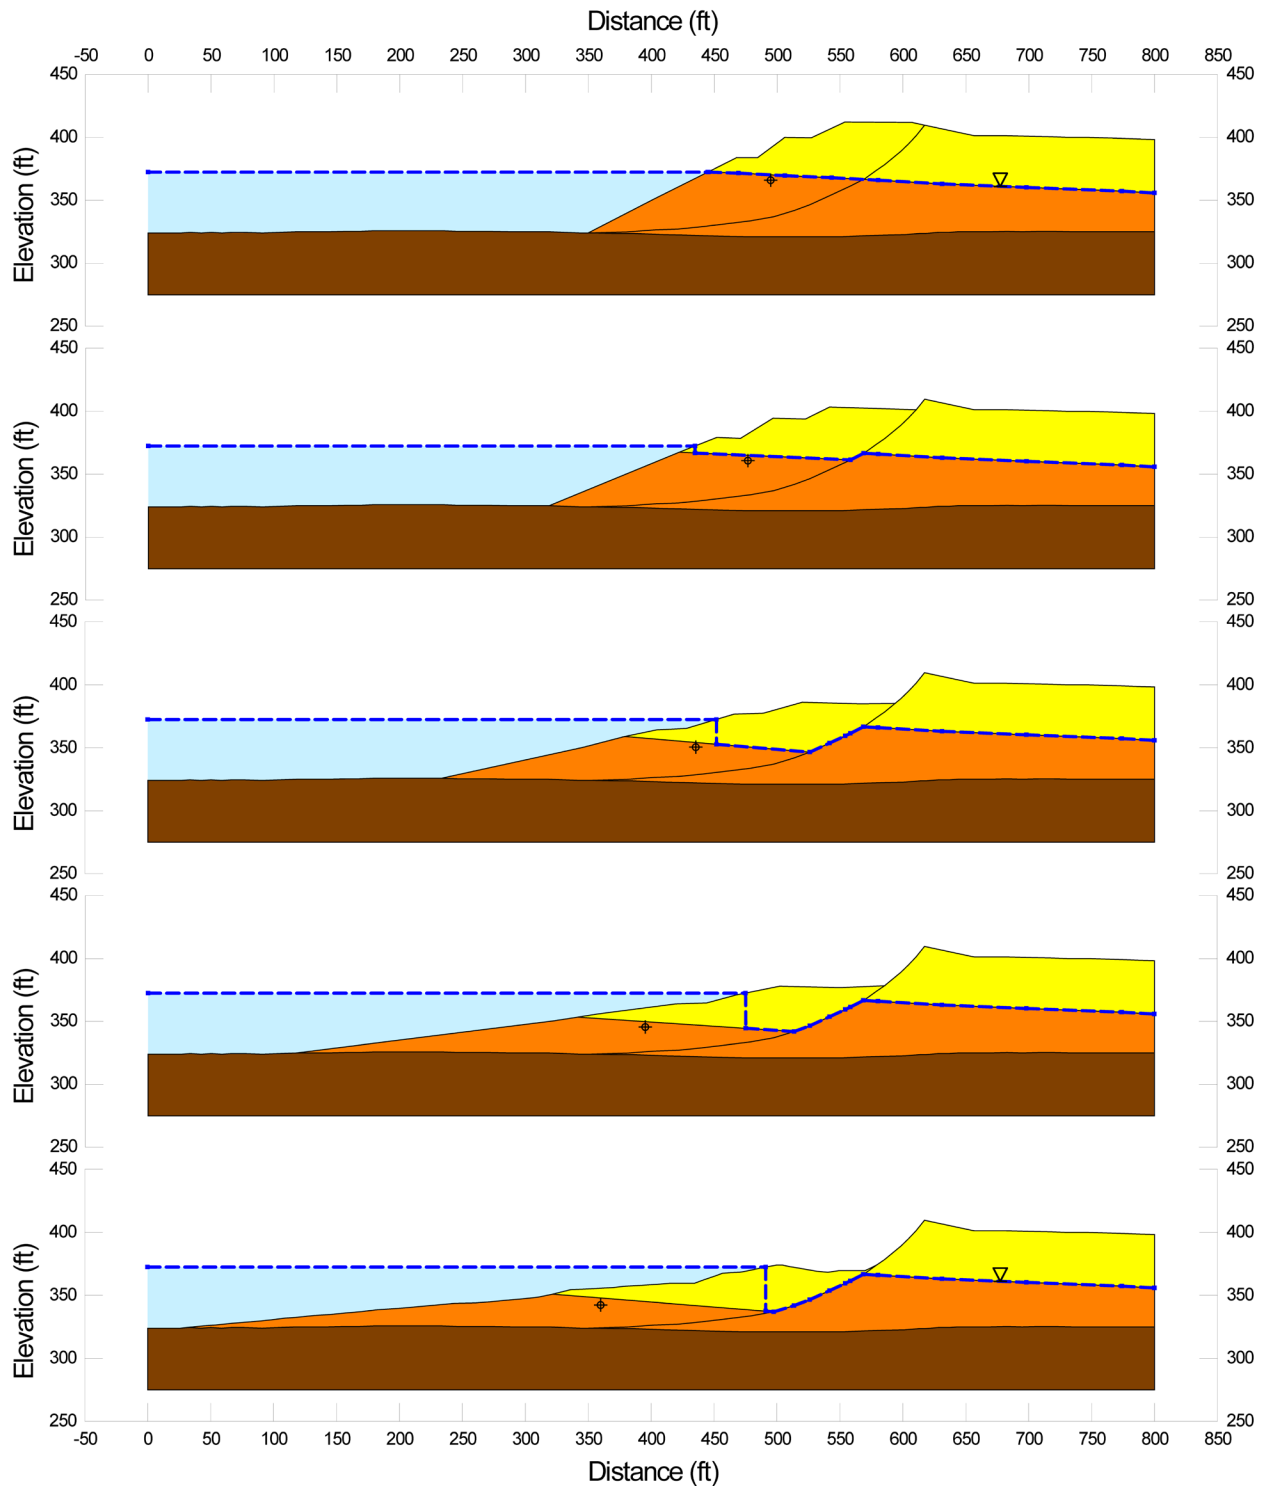
Figure A.1.4: Incremental momentum analysis of the failure of the North Dike of the Wachusett Dam, showing progressive evolution of cross-section geometry modeled.

Figure A.1.4 shows the best-estimate progressive incremental inertial analysis, showing the five stages of geometry evolution modeled as the failure proceeds. Figure A.1.5 shows the associated calculations of (1) acceleration vs. time, (2) velocity vs. time, and (3) displacement of the overall center of gravity vs. time. The resulting best estimate value of post-liquefaction strength was $S_r = 294 \text{ lbs/ft}^2$.

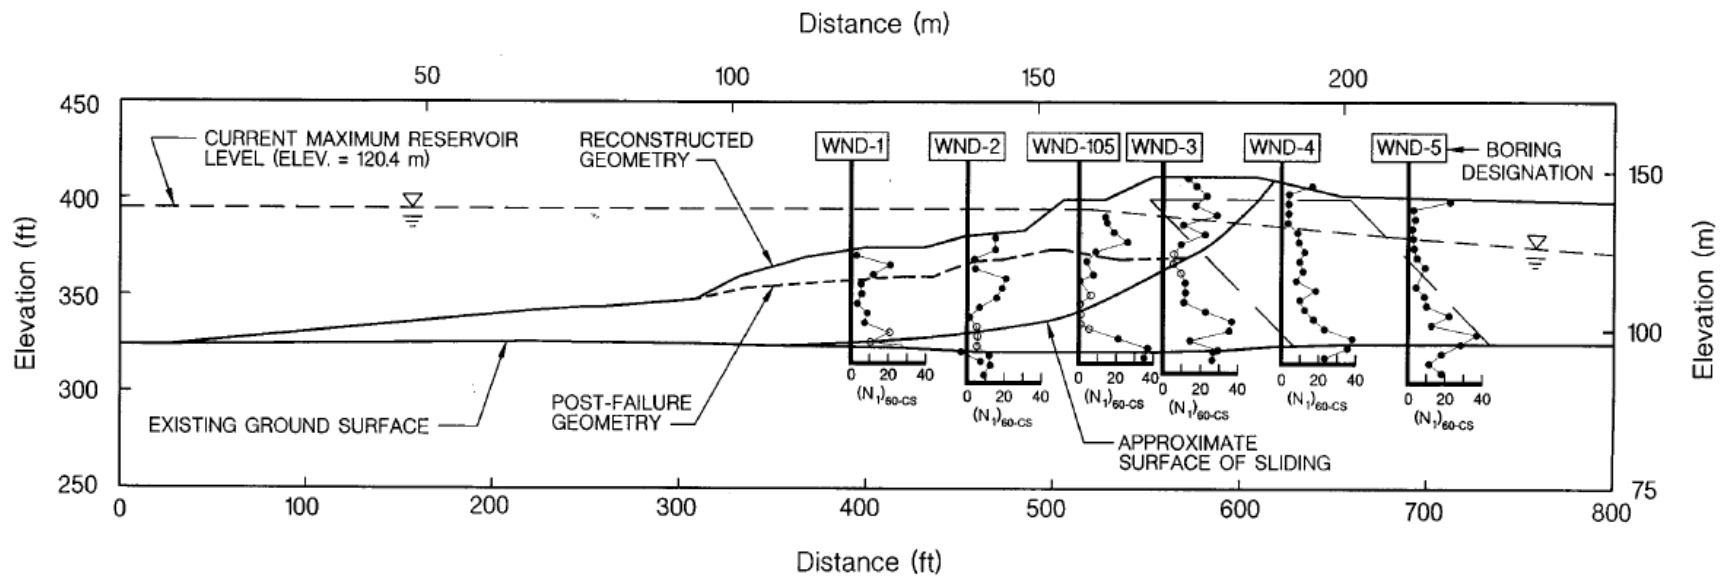
Figure A.1.6: Reconstructed cross-section of the North Dike of Wachusett Dam showing the locations and results of recent standard penetration tests (from Olson et al., 2001).

The field investigations reported by GZA Environmental (1991) and by Haley & Aldrich (1984a,b) included six SPT borings at the reconstructed failure section at Station 23+20. These are shown in Figure A.1.6. All of the borings were advanced by rotary wash boring, and a donut hammer with rope and cathead was used to drive the SPT samplers. The SPT hammer energy ratio was taken to be approximately 45%, as was used by Olson et al. (2000) and Olson (2001) in their back-analysis of this case history. Thirty of the SPT’s were performed in the upstream shell materials involved in the 1907 flow failure. Thirteen of these were performed near to the apparent shear failure surface, and these are shown with open circles in Figure A.1.6. A source of uncertainty, therefore, is how to weight the SPT blowcounts apparently “near” the failure surface vs. the rest of the SPT blowcounts in the upstream shell material. In these current studies, equal weighting was given to the thirteen blowcounts near the failure zone vs. the full ensemble of blowcounts in the upstream shell materials (assuming that variation is random, and that blowcounts might be distributed differently at nearby locations).

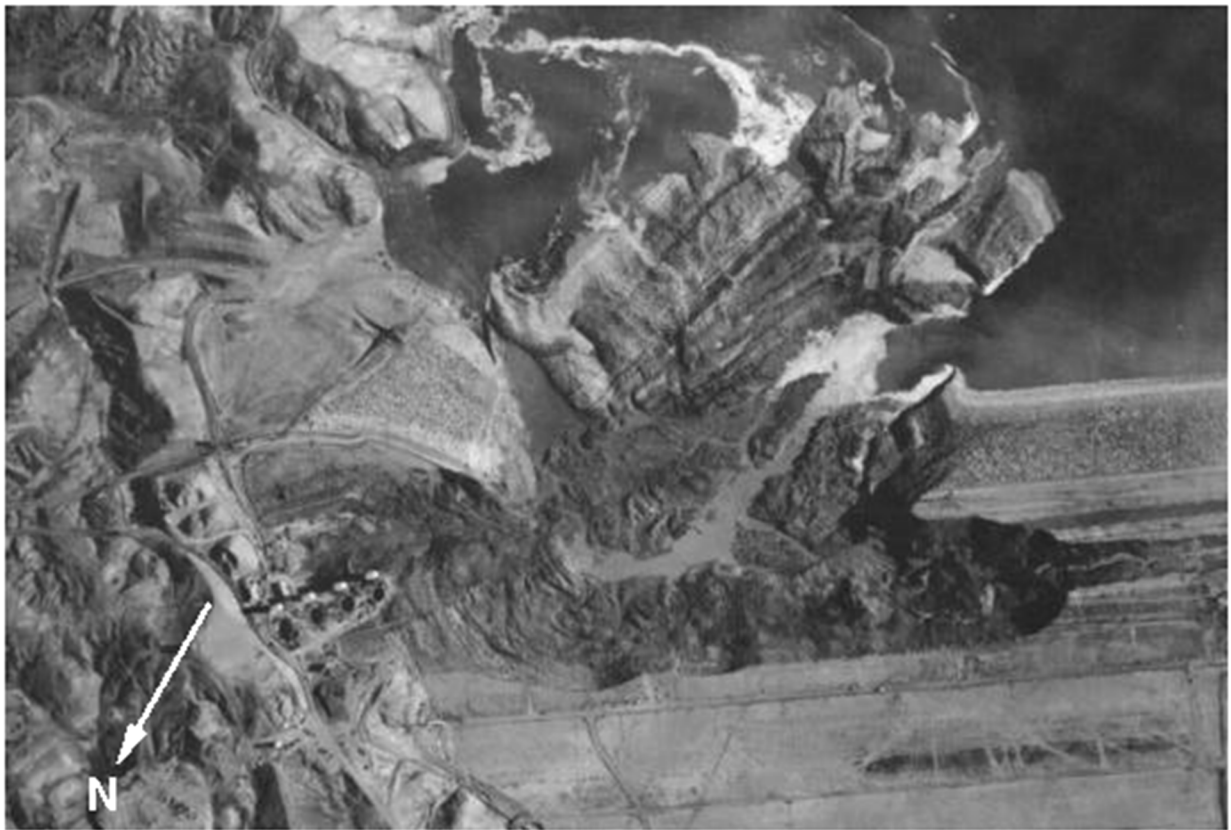
Figure A.2.2: Enlarged aerial photo from Figure A.2.1 showing failure at the east end of the dam. (from <http://www.midrivers.com/~rafter/lake/>)

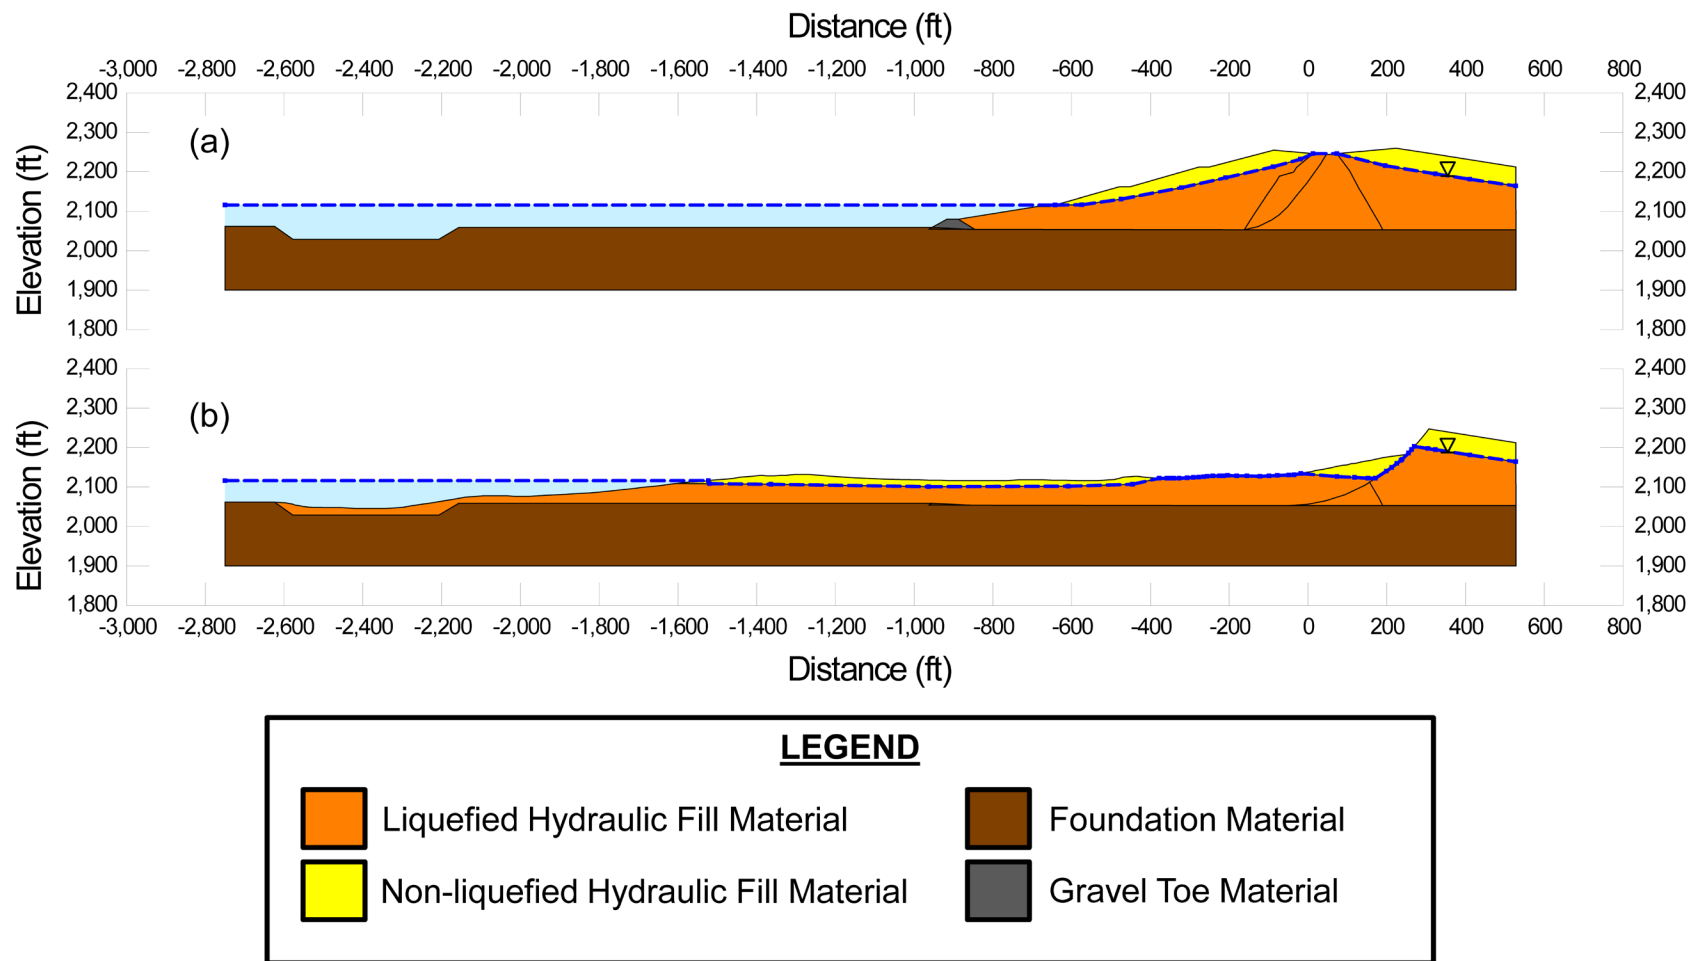
Figure A.2.8: Fort Peck Dam: (a) Pre-failure geometry and best-estimate failure surface for initial yield stress analyses, and (b) post-failure geometry and best-estimate failure surface for post-failure residual geometry analyses.

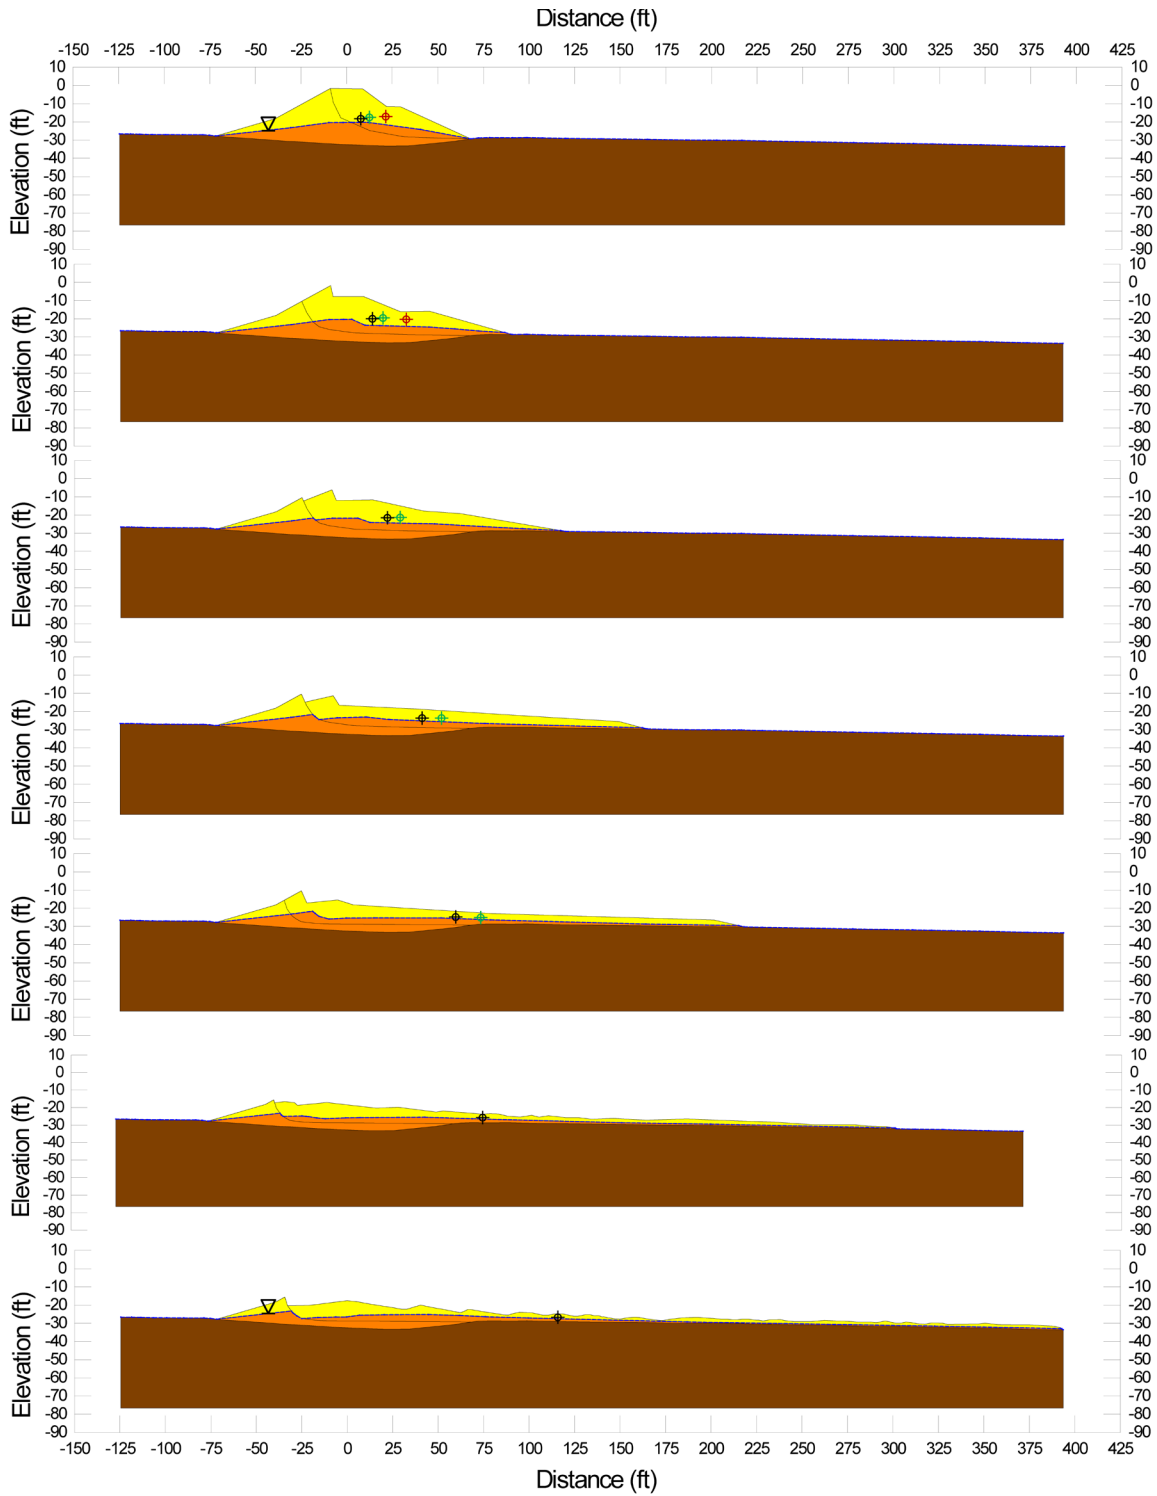
Figure A.3.3: Incremental momentum analysis of the failure of the Uetsu Line Railway Embankment, showing progressive evolution of cross-section geometry modeled.

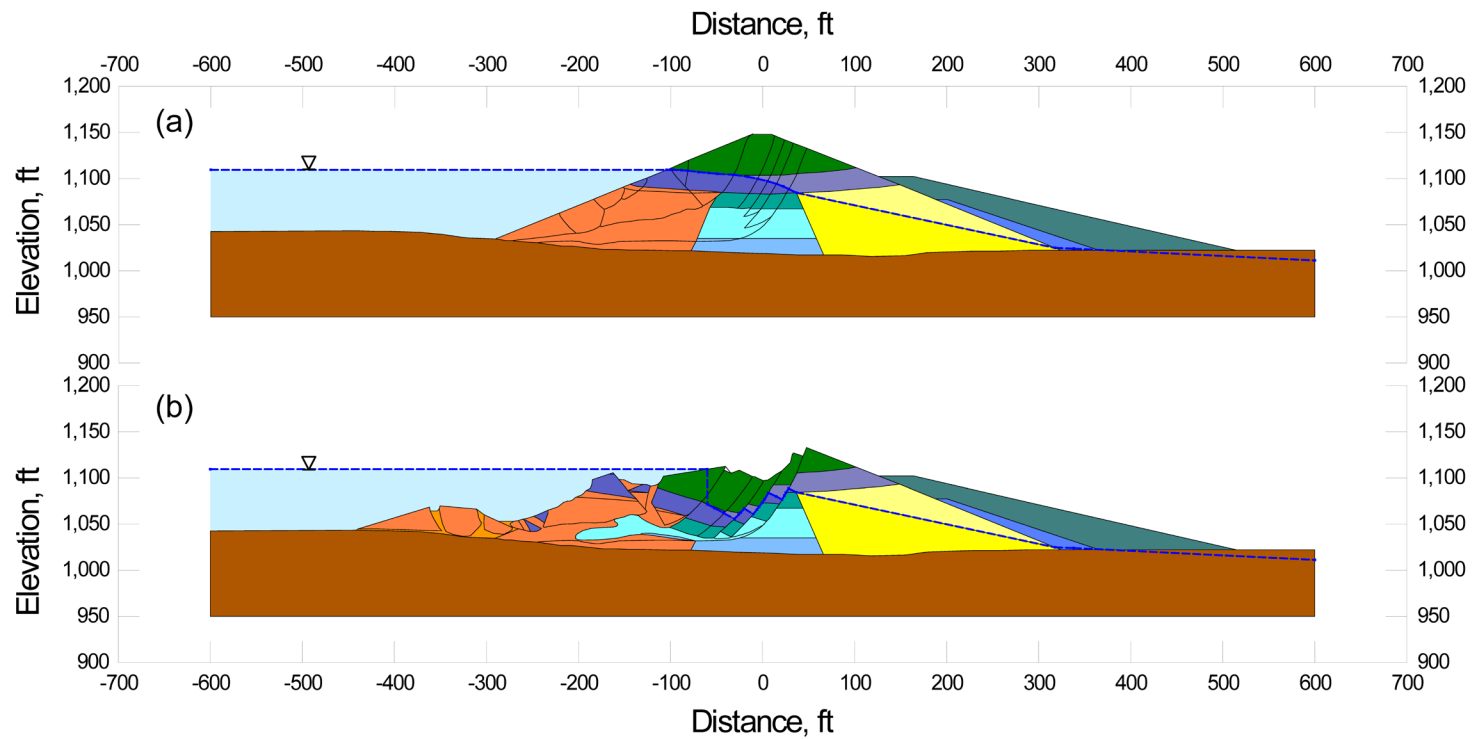
Figure A.4.2: Lower San Fernando Dam: (a) Pre-failure geometry and best-estimate failure surface for initial yield stress analyses, and (b) post-failure geometry and best-estimate failure surface for post-failure residual geometry analyses.

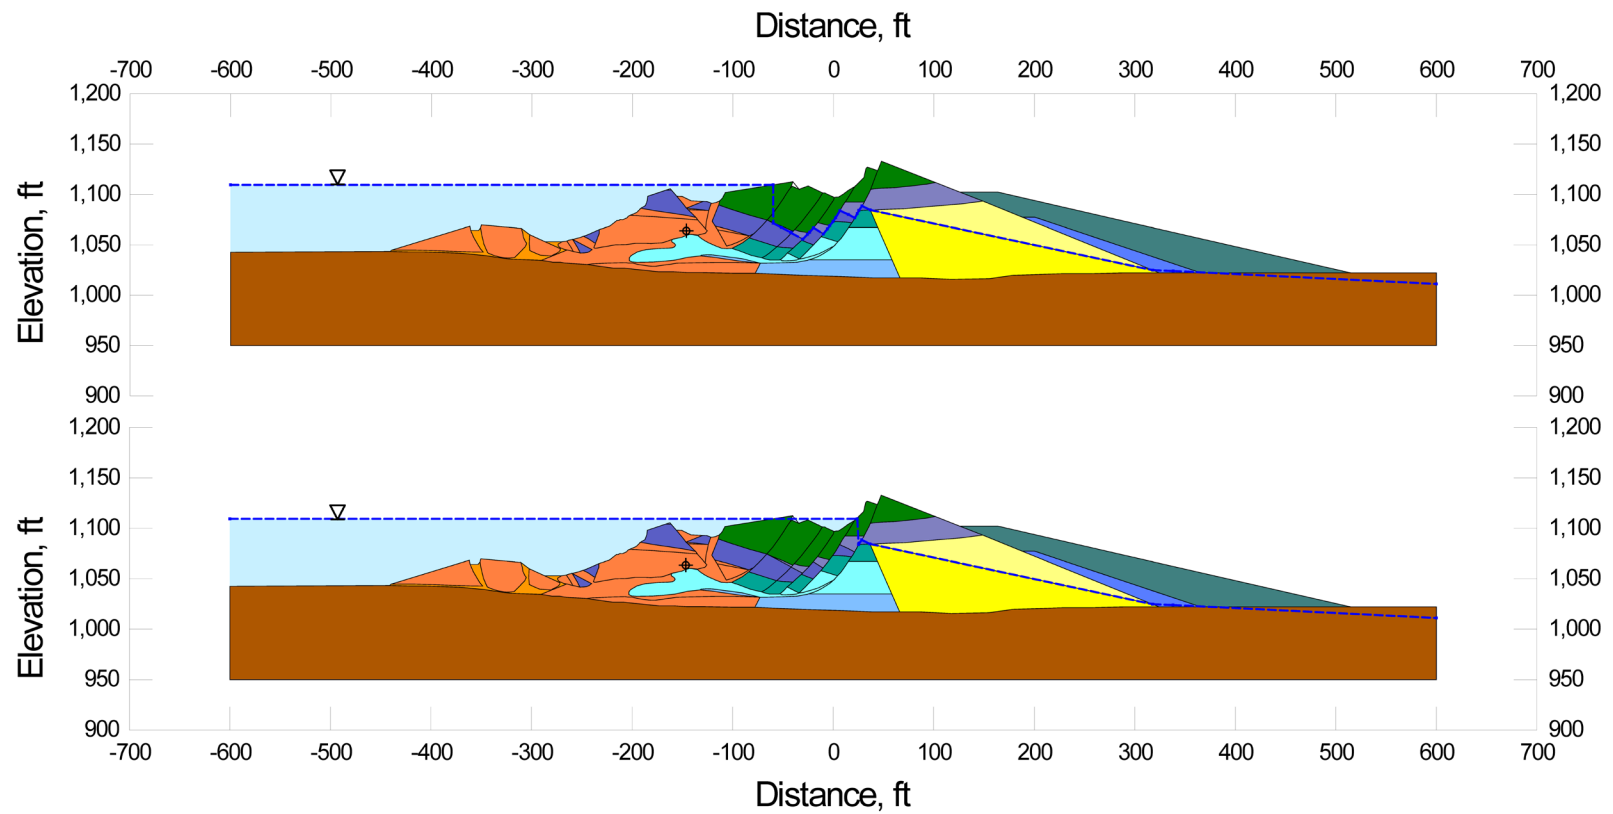
Figure A.4.4: Incremental momentum analysis of the failure of the upstream side of the Lower San Fernando Dam, showing progressive evolution of cross-section geometry as modeled for the best-estimate case.

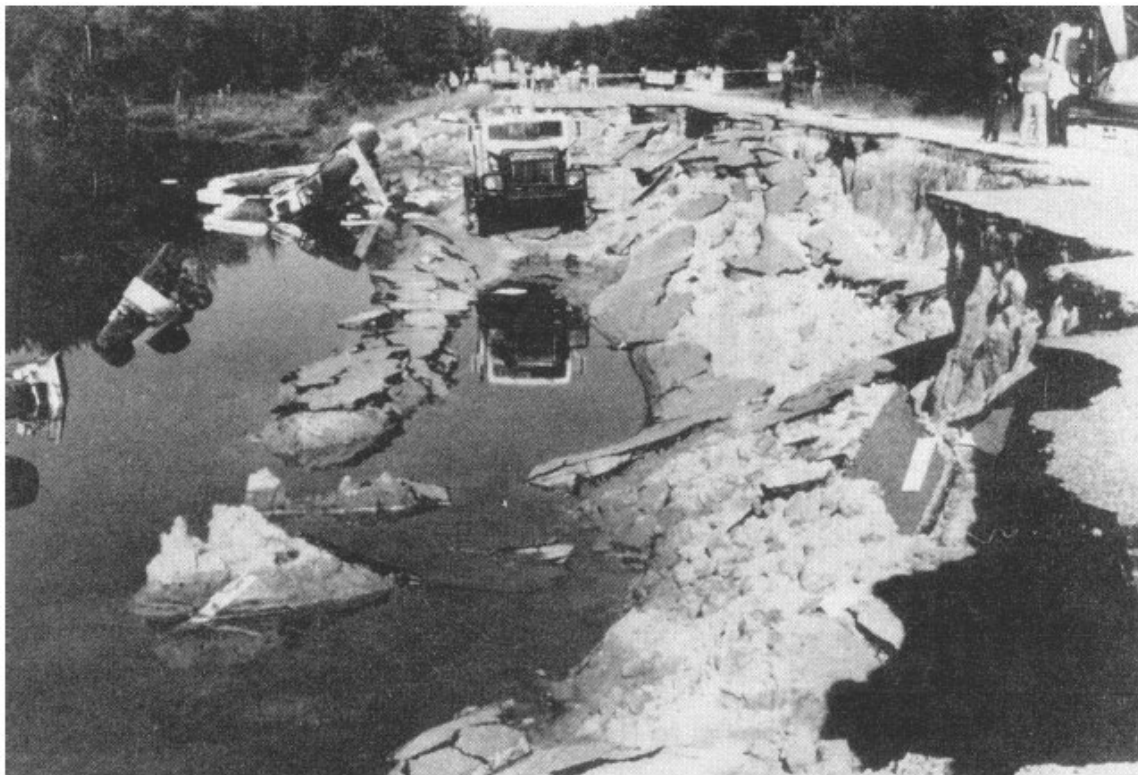
Figure A.9.2: Photograph showing the failed embankment (looking towards the west), showing crest loss and the positions of four of the large geophysical exploration trucks. (Hryciw et al., 1990).

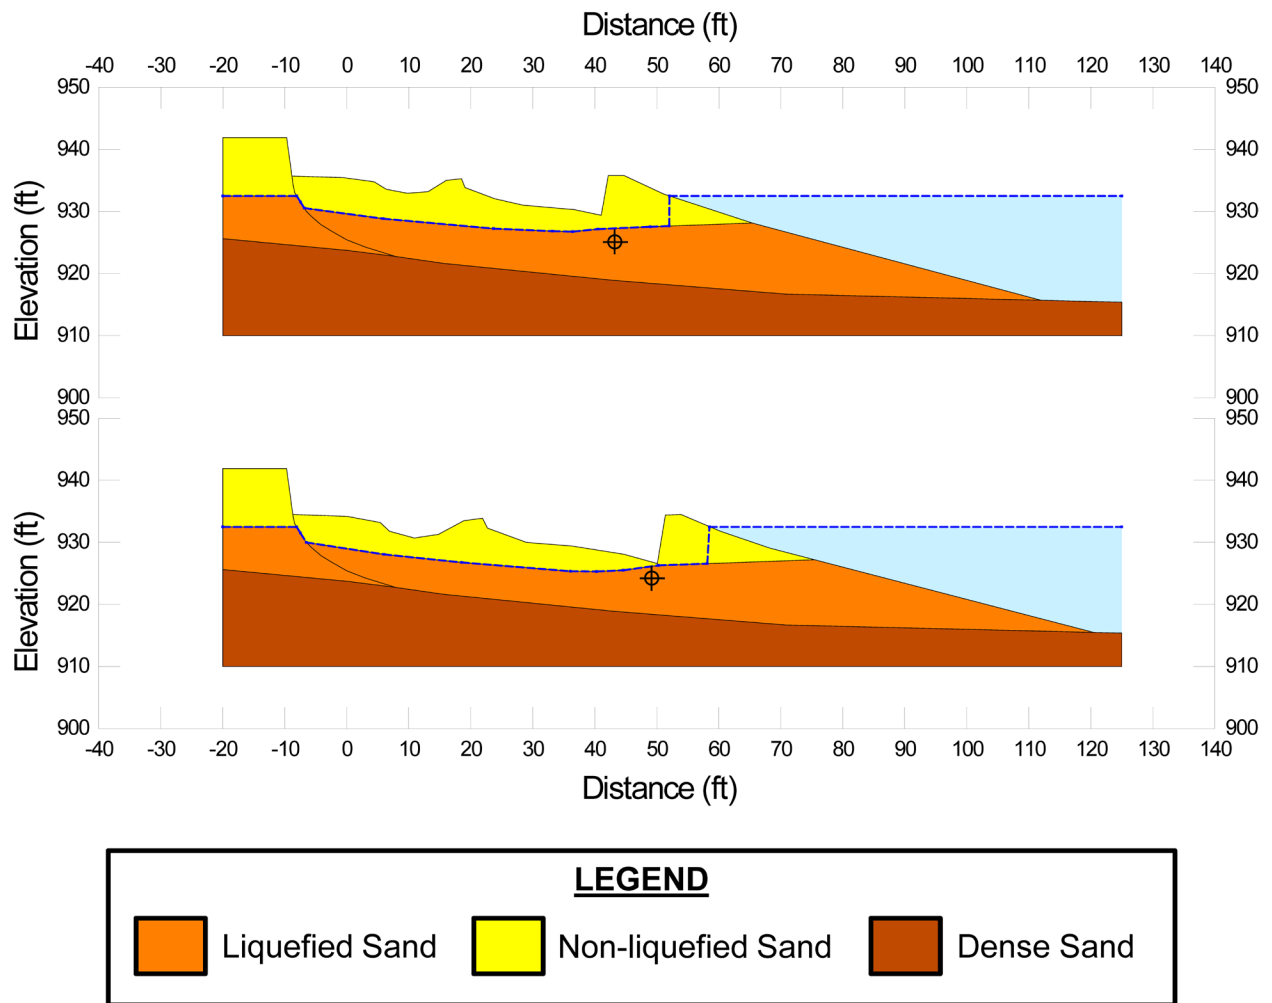
Figure A.9.9: Figure A.9.8 repeated, at larger scale, now also showing the progressive locations of the center of gravity of the overall failure mass.

Figure A.9.9 (cont'd): Figure A.9.8 repeated, at larger scale, now also showing the progressive locations of the center of gravity of the overall failure mass.

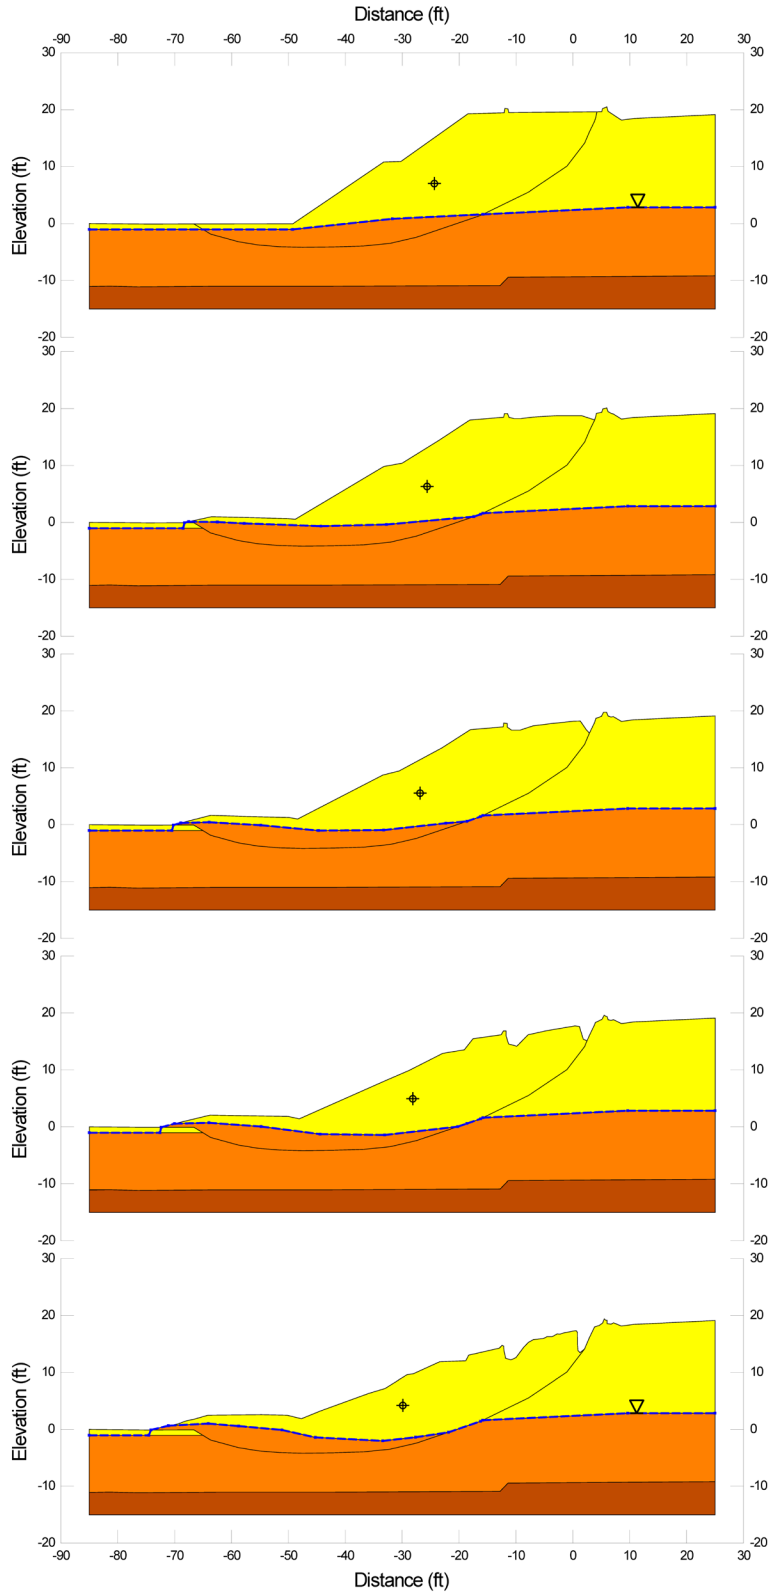
Figure A.10.6: Incremental momentum analysis of the failure of the fill slope at Chonan Middle School, showing progressive evolution of cross-section geometry modeled.

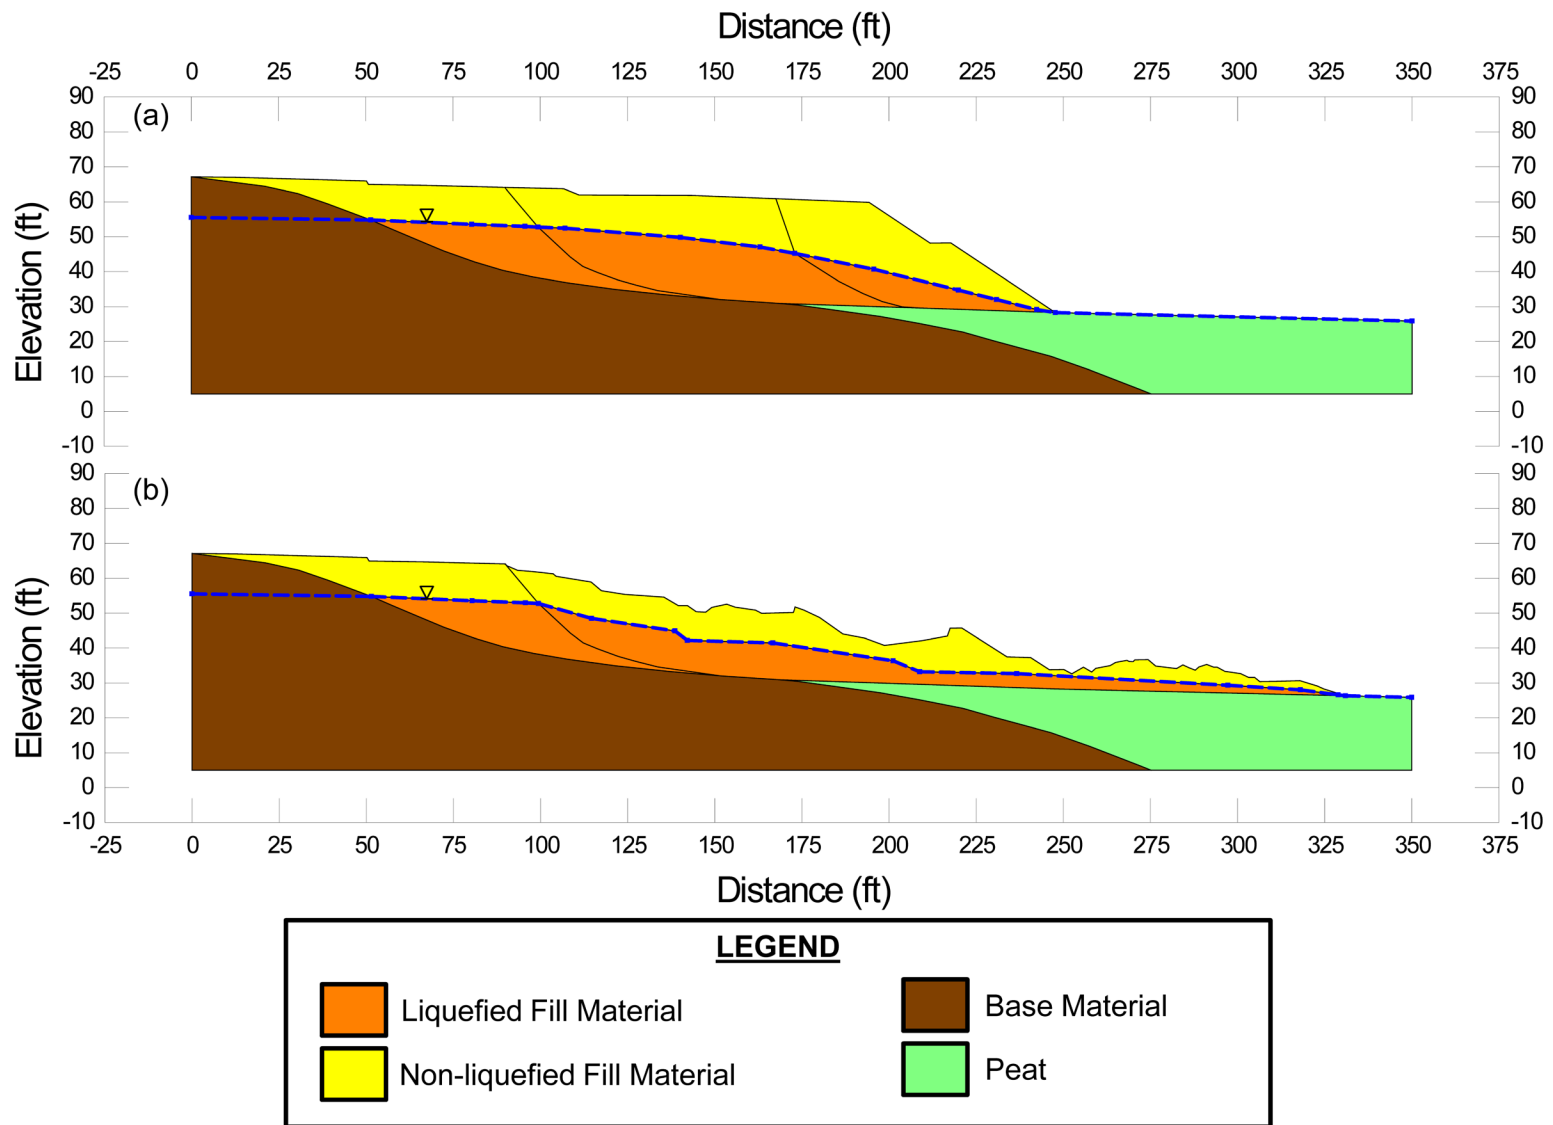
Figure A.12.4: Shibecha-Cho Embankment cross-section showing (a) pre-failure geometry showing failure surfaces used for initial yield stress analyses, and (b) post-failure geometry and best-estimate failure surface for post-failure residual geometry analyses.
